## LEE \* LICKLE HOUSE (SITE)

## INVENTORY FORM FOR STATE HISTORIC SITES SURVEY

Lee-Lickle House (Site)

BA-1428

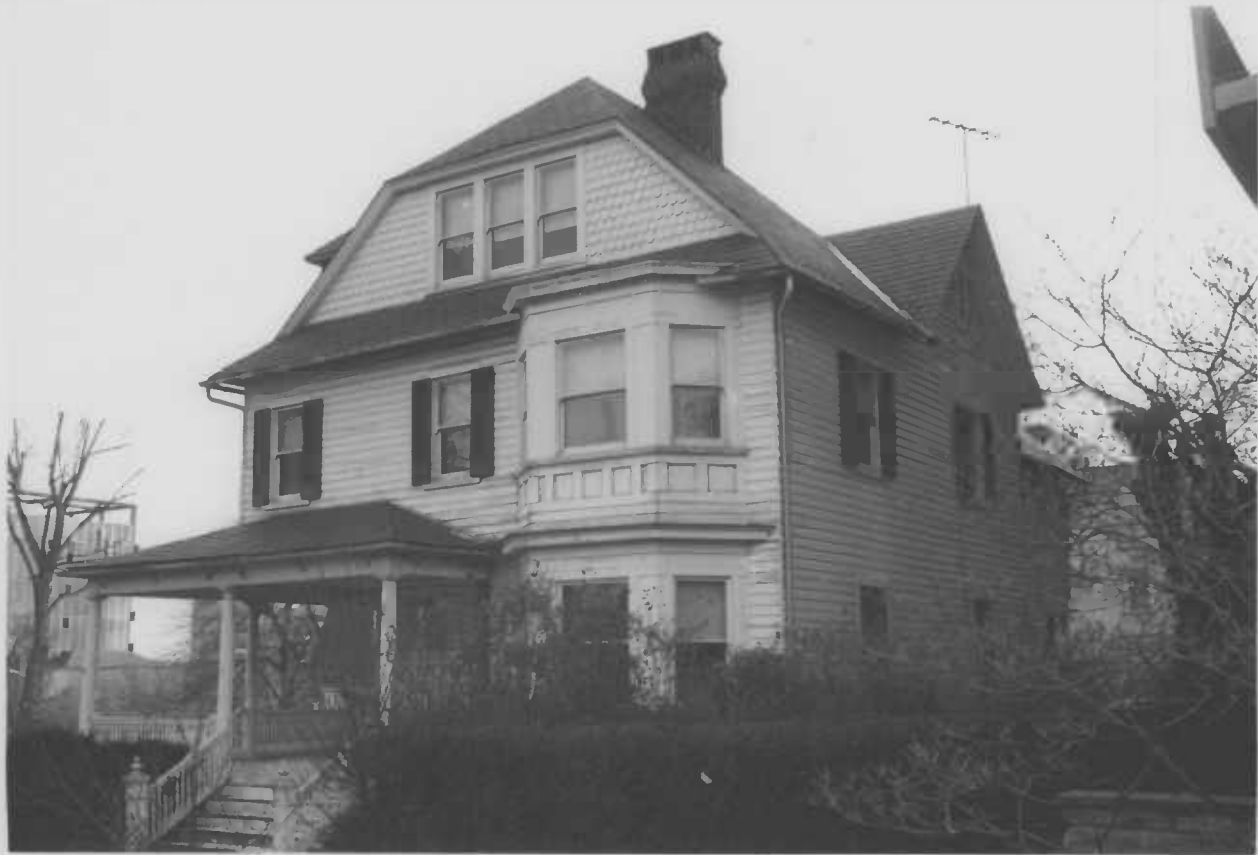
N.W. CORNER

The cross gabled north facade is noticeably plain and comparatively monolithic, a feature probably determined by the fact that the building shared a straight border on the West with a close neighbor.

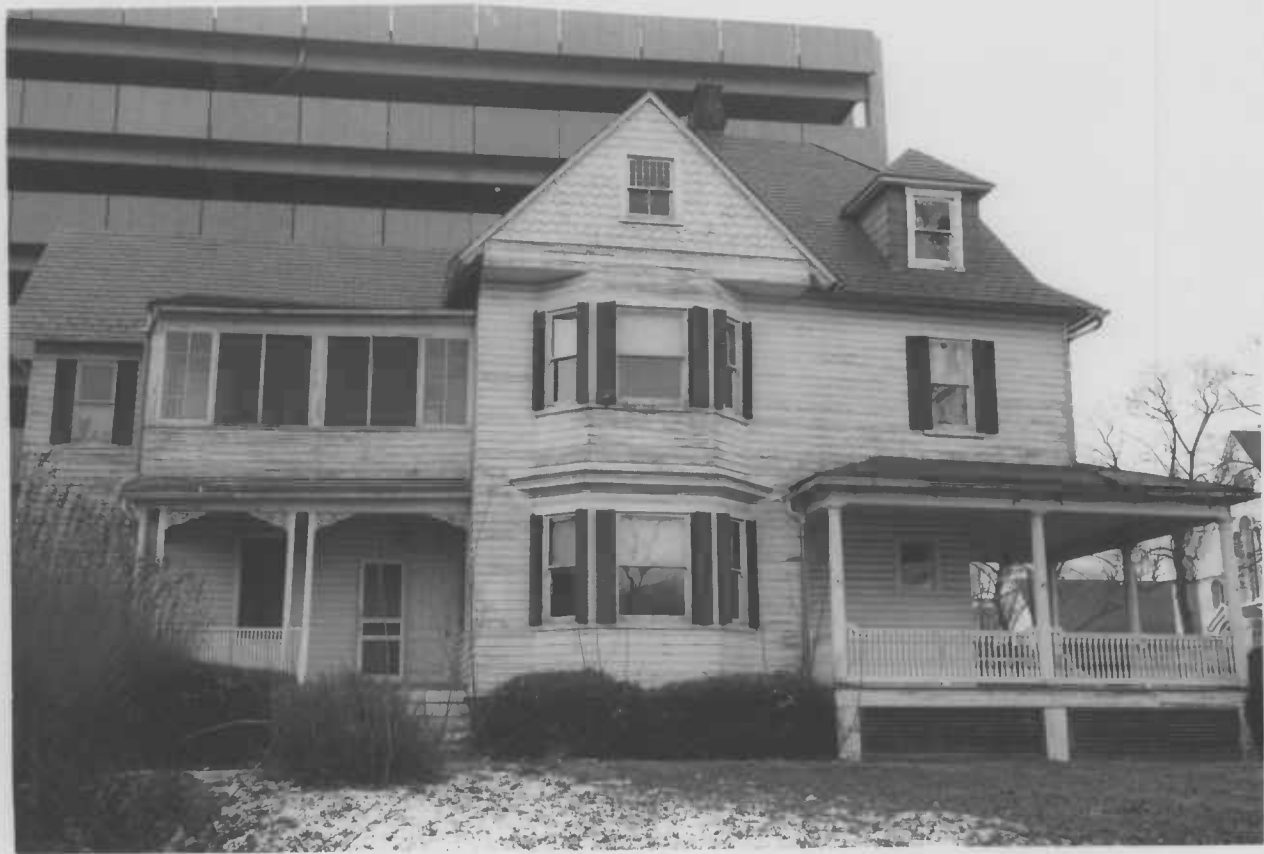
E. FACADE

The wrap around porch may be a response to the fact that the house occupied a corner lot which was unshared prior to the construction of Dr. Jarrett's office in 1900. The east facade therefore has the same frontality as the North

which is differentiated primarily by the formal porch entrance. Another swell-front can be seen in the central bay of this facade. It lights the dining room downstairs and an upstairs sitting room. A deeply corniced and sharply pitched gable tops the swell-front. This gable is vented by a decorative 18/1 window. A hipped roof dormer with a 1/1 window caps the north bay. A two story wing takes up the south bay. Porches cover both stories. The lower porch has the same turned columns and brackets as the back (south) porch. The upper porch or gallery is perceived as original by virtue of the same beveled siding as is seen in the exterior having been used to panel the interior wall. No proof exists that this was a "sleeping porch" but its proximity to the sleeping rooms and the sliding windows and screens supports such a description.

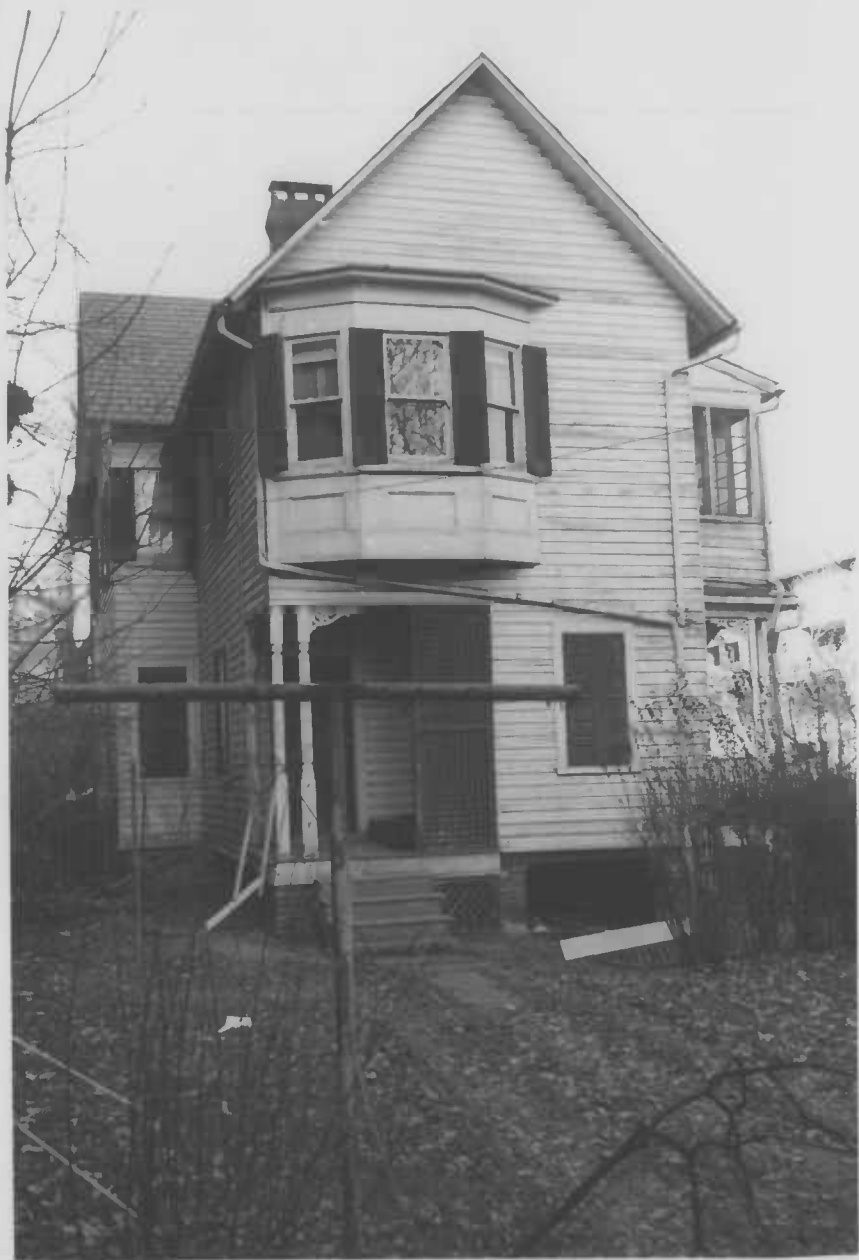
LEE-LICKLE HSE.  
S.

The south side or end of the house is narrow due to the T-plan of the house. It is two bays in width. A porch occupies the west bay and makes the southwest corner a negative space on the first story. The pantry windows vent the East on the first floor and a three sided bay window lights the second story.

The attic level is windowless but is shaped by a steeply pitched and open corniced gable.
